## **Annex 11 – Case study: London Borough of Camden**

Building Research Establishment Ltd, UK

August 2004

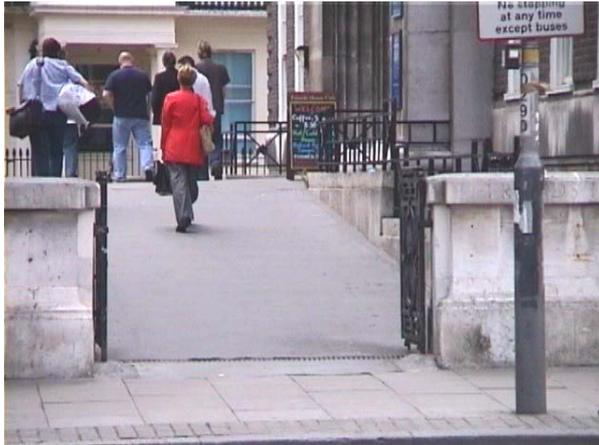
- a. There is a footpath through the gardens linking Euston Road and Endsleigh Gardens. This 'through route movement generator' is used as a shortcut and is therefore a significant source of anonymity. It also provides alternative escape routes. (Figs 1–3)

Fig 1: Entrance to gardens from Euston Road.

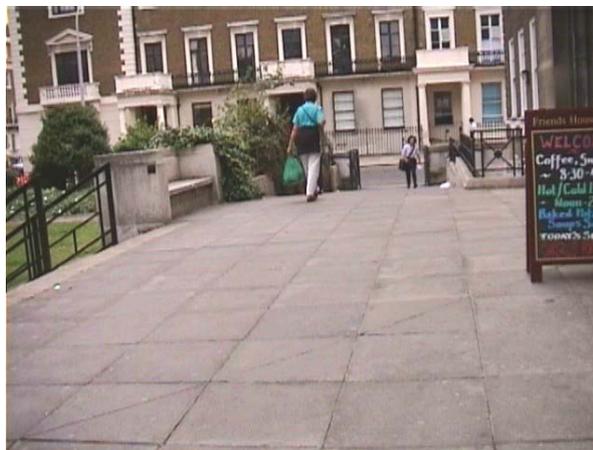
Fig 3: Endsleigh Gardens entrance/exit from the gardens.

- b. In effect, although the garden should be private space, it is de facto public space, and it is this that will influence the lack of territoriality by the owners.

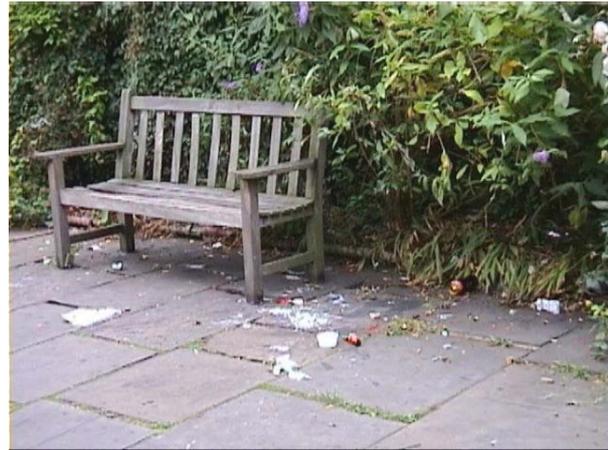
Fig 5: Overgrown plants (and litter).

- vii. The gardens should be weeded and the overgrown plants should be trimmed.
- viii. The open basement area should be fitted with lids similar to those used elsewhere in this part of London to prevent the dropping of litter. (See Fig 9) N.B. It should be borne in mind that any basement lid, window sill etc. is a potential resting place for a terrorist's improvised explosive device. As a result, this lid, and any others recommended in this analysis should be fitted on an incline to reduce the possibility of such an attack.<sup>xxii</sup>

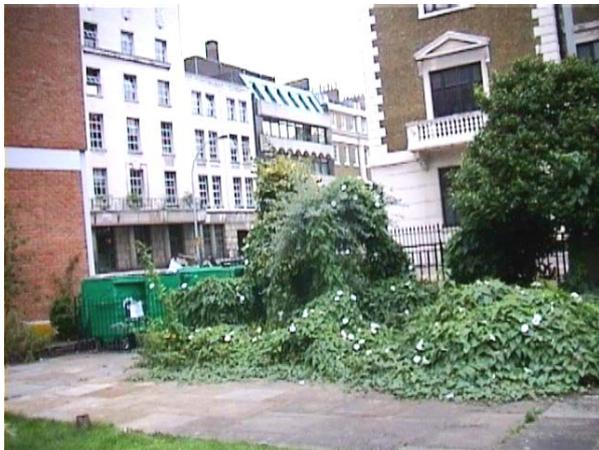
Fig 6: Overgrown plants (and litter) also showing badly placed re-cycling bins.

- i. The gardens should be thoroughly tidied and cleaned up. In particular, all the drugs paraphernalia and litter should be removed.
- ii. Once tidy, the space should be kept tidy.
- iii. The re-cycling area should be moved to a less sensitive area.
- iv. All litter bins should be emptied at least once a day, and more frequently if required. Additional fire resistant litter bins should be provided.
- v. All graffiti should be removed, and surfaces painted over with anti-graffiti finishes.
- vi. Any damaged benches should be repaired.

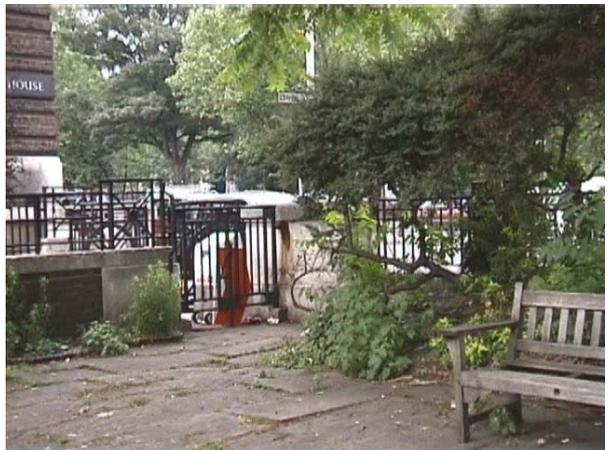
Fig 7: The hedge boundary fronting Euston Road.

- x. The existing wall and any additional length at the Endsleigh Gardens end should be significantly raised by fitting substantial, vandal resistant ornamental railings flush with the edge of the wall on the Endsleigh Gardens side. The recommended additional height would be at least 1.5 metres above its present level.

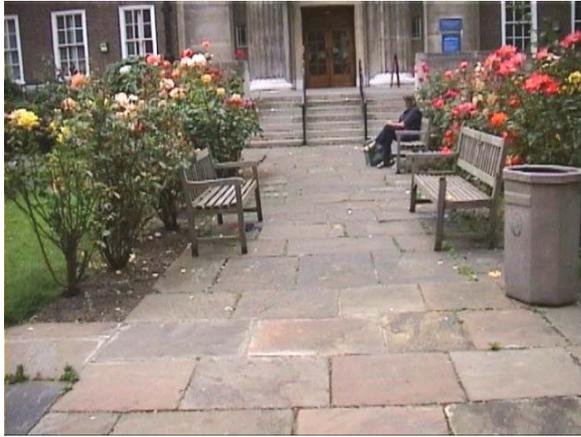
Fig 8: Opportunities for anonymity.

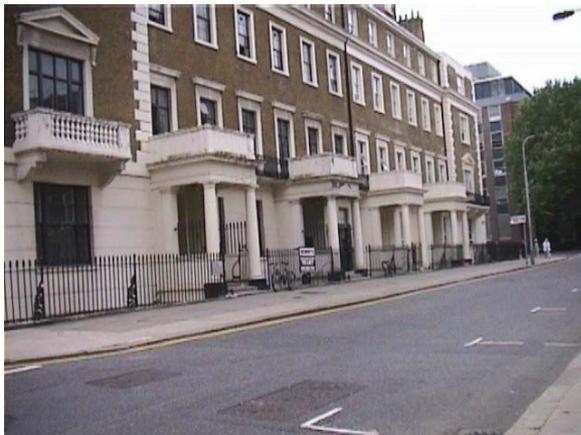
- a. A number of the terraced houses lining the south side of Endsleigh Gardens are dirty and in a poor state of repair, in some cases bordering on dereliction. All these houses have open basement areas which have had assorted litter dumped in them. The environmental cues here are poor and include graffiti, litter and minor damage. (See Figs 10–12)
- b. Many of the items of street furniture have stickers and graffiti on them; where anti-vandal/anti-fly posting finishes have been applied, many are cracked and damaged.
- c. All of the basements have security bars at their windows, and it is highly probable that this area will be vulnerable to:
  - burglary
  - robbery
  - criminal damage
  - assault on and by vagrants
  - drug offences.

Fig 10: South side of Endsleigh Gardens.

- iv. All graffiti should be removed, and surfaces painted over with anti-graffiti finishes.
- v. All street furniture should be cleaned up and stickers etc. should be removed. Anti-fly sticker finishes should be applied. N.B. Throughout the study area, the majority of items of street furniture are in a similar state as the ones discussed here. These recommended solutions should therefore be applied to all street furniture.

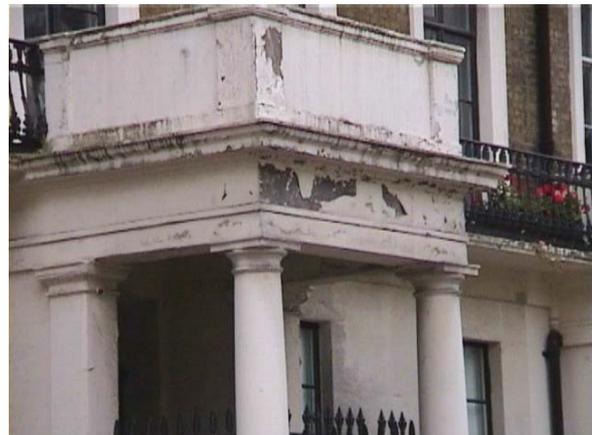
Fig 11: Close up view of Endsleigh Gardens, showing poor environmental cues.

- a. Many of the houses appear to have been divided into flats whose tenants probably include students from the nearby campus of University College. This will create high levels of anonymity and a lack of territoriality.
- b. The poor state of this area has created a classic ‘broken windows’ scenario.
- c. The proximity of the Gardens discussed above, and the presence of vagrants, drug abusers etc. will influence the general ‘climate’, making it more favourable for crime and disorder than it would otherwise be.

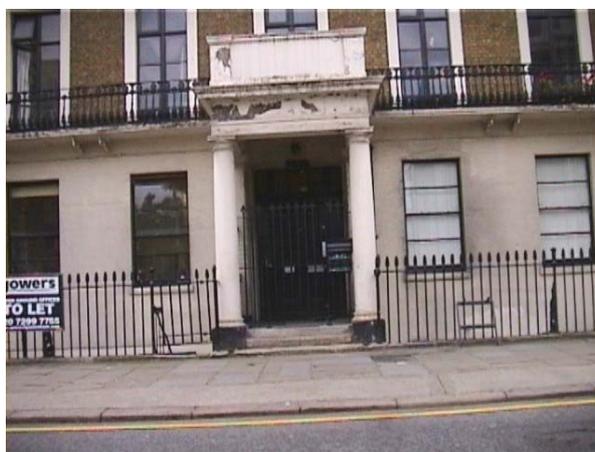
Fig 12: Close up view of Endsleigh Gardens, showing poor environmental cues.

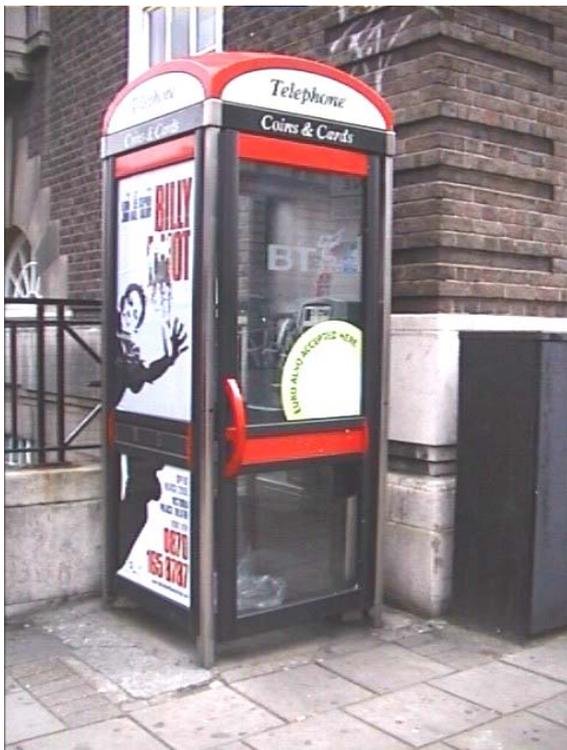
- a. The location of the box in an area that is already suffering from a variety of litter and graffiti problems means that such problems are commonplace and therefore tend to be ignored. “No one else bothers, so why should I?” A classic ‘broken windows’ situation.
- b. The large, legal advertisements placed on the windows of the box by the telephone company have obscured the inside giving freedom to carry out illegal acts.
- c. This has created both anonymity and freedom from surveillance, both of which influence the criminal ‘climate’ of the area.
- d. The box lies on a direct route between the West End and Euston Station, and there are very few public lavatories open in this area.

Fig 13: Existing BT telephone box showing lack of visibility.

- i. The telephone box is acting as a catalyst for crime, and if it were removed it could well have a positive influence on the rest of the area. Ideally therefore, (in order of preference) the telephone box should be:
- Removed.
  - Replaced with an open fronted box. (See Fig 14)
  - Replaced with a ‘motorway’ style box (with only an acoustic hood)
- ii. Whether or not the existing box is removed or replaced, the following should be implemented both here and in any other telephone box in the study area:
- All rubbish should be removed and the box should be thoroughly cleaned and disinfected.
  - When cleaned, the box should be kept clean.

- The large advertisements should be permanently removed.
  - The sex cards should be removed on a daily basis.
  - Consider treating the inside surfaces of the box with dimpled finishes to resist cards being stuck on them.
  - Consider filling in all cracks in surfaces that could be used to 'insert' a card of any kind.
- iii. Consider installing public conveniences in the area.
  - iv. Consider enforcement action by all the interested agencies.
  - v. Consider a partnership arrangement between landlords, Network Rail, UCL, the Police and Camden Council for additional capable guardians to 'patrol' this area'.
  - vi. Consider if Section 17 Crime and Disorder Act 1998 will assist in any of these actions.

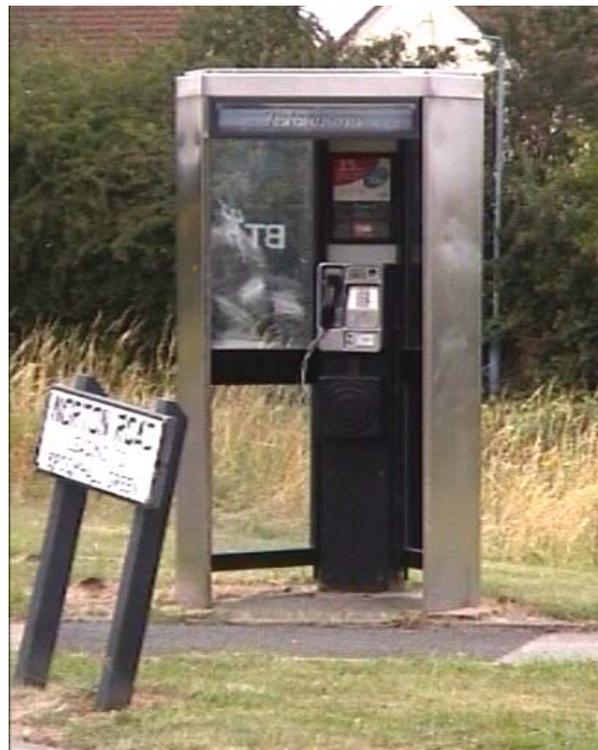
Fig 14: Alternative BT telephone box.

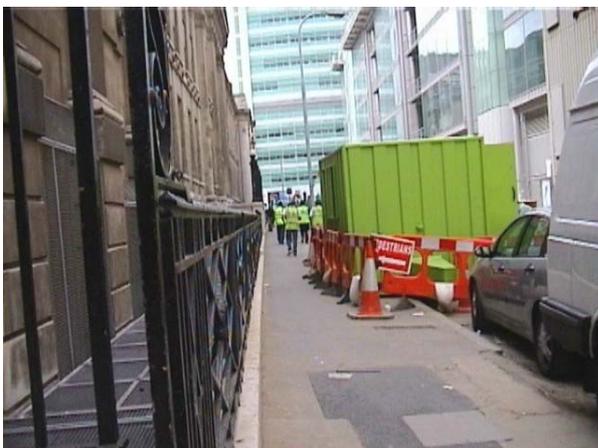
- a. This is a short cut movement generator between the West End and many of the University's student accommodation (and the Student Union bar). It provides all three of Newman's crime generators, i.e. anonymity, freedom from surveillance and alternative escape routes.
- b. On the left of the road when walking towards Tottenham Court Road, the University is on the left and the construction is on the right. As a result, there is no ownership of the street and a corresponding lack of territoriality.

Fig 15: Construction work in Gower Place, showing tunnel effect.

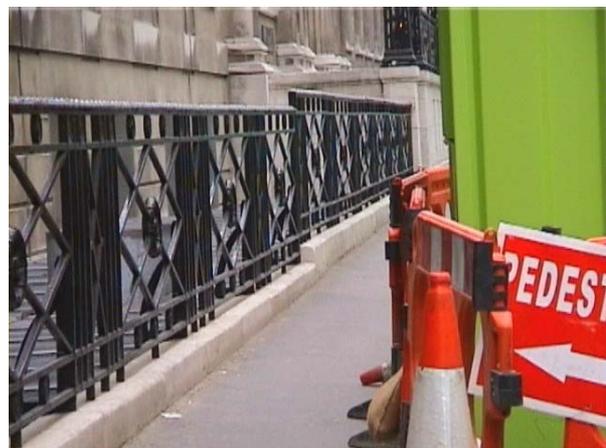
Fig 16: Close up of Fig. 15.

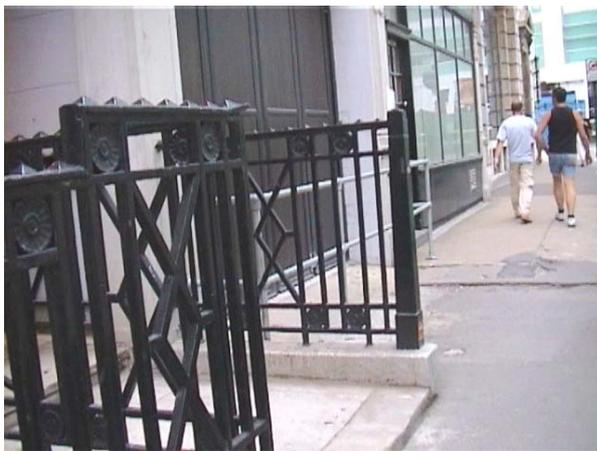
- a. At the Gower Street end of Gower Place on the left hand side looking towards Tottenham Court Road, there is an indented doorway with a walkway over a basement. (See Figs 17 and 18)
- b. This is a classic place for rough sleepers to sleep, for drug abusers to misuse drugs and for use as an alternative lavatory etc.

Fig 17: Indented doorway.

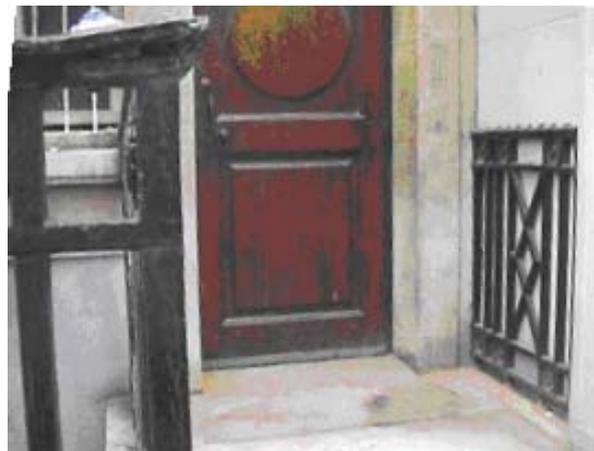
Fig 18: Close up of Fig. 17.

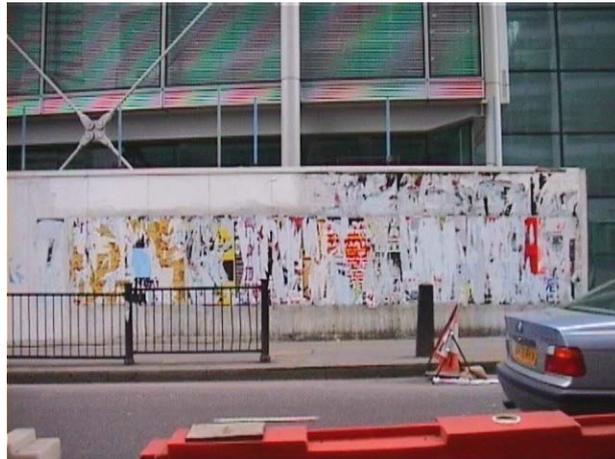
- a. There is large-scale construction in this area, and hoardings have been erected to enclose the works. In places, these hoardings have been significantly fly posted.
- b. The whole area is dirty, there is widespread litter and graffiti and street furniture is giving off poor environmental cues. (See Fig 19)

Fig 19: Badly defaced hoarding giving off poor environmental cues.

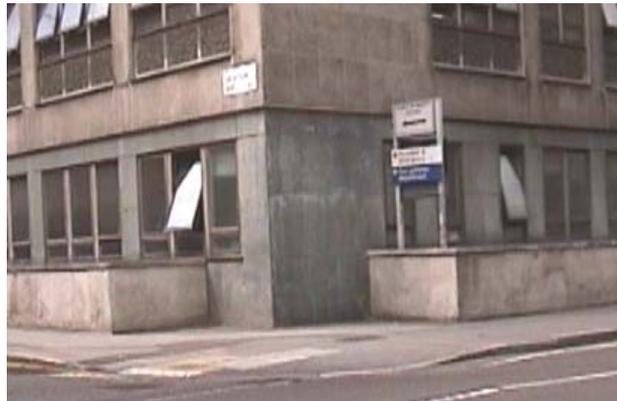
- a. The corner of University College Hospital (UCH) has a number of indented areas, and the walls in this area have been painted with graffiti. (See Fig 20)
- b. The area is dirty and litter strewn.
- c. This is clearly an area where there is a potential for a range of anti-social behaviour including:
  - assaults
  - robbery
  - drug offences
  - drunkenness
  - criminal damage
  - general anti-social behaviour.

Fig 20: Indented areas.

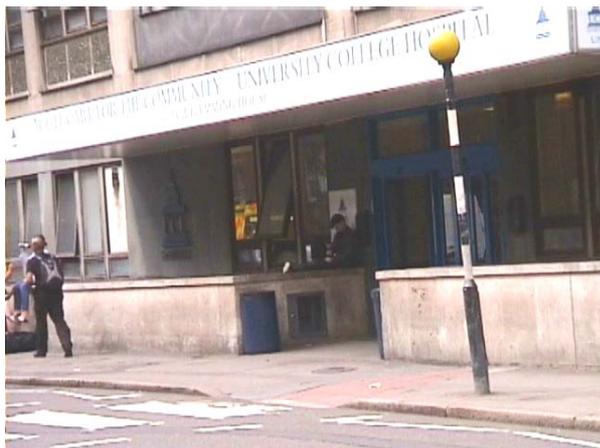
- a. On either side of the A & E entrance to UCH is a wall in front of basements. They are currently covered with steel mesh, but this is dirty and has rubbish including empty beer cans dumped on it. (See Figs 21 and 22)
- b. This is a smokers' area for the A & E Department of UCH and people cluster around the entrance sitting on the low wall. As with other A & E departments this area is likely to be a flash point for aggressive anti-social behaviour, particularly on Friday and Saturday nights, and therefore there is a need to reduce clustering on the street. (See Figs 23 and 24)
- c. This is clearly an area where there is a potential for a range of anti-social behaviour including:
  - assaults
  - robbery
  - drunkenness
  - drug offences
  - criminal damage.

Fig 21: Entrance to the A & E Department of UCH.

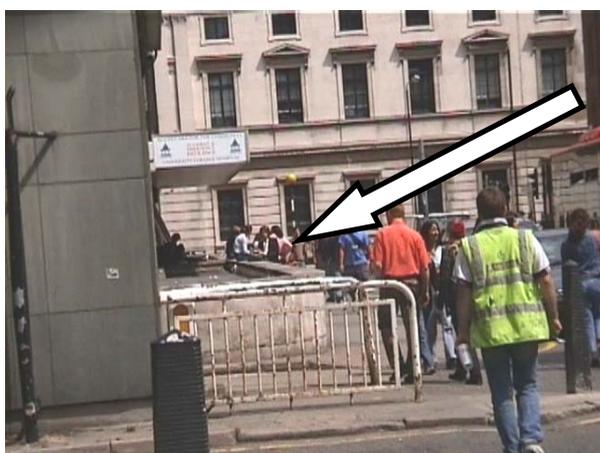
Fig 23: Clustering around the entrance of the A & E Dept.

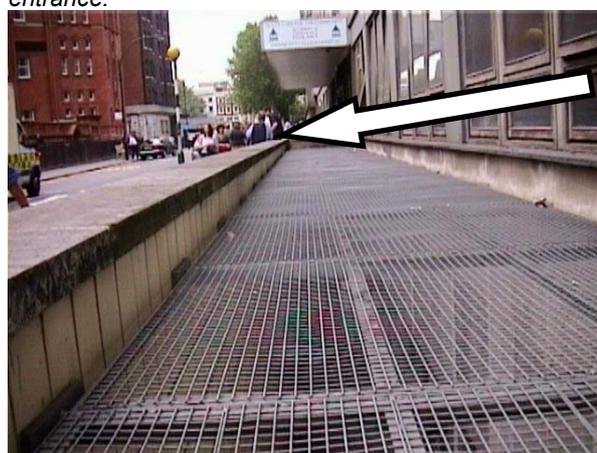
Fig 24: Clustering around the entrance of the A & E Dept

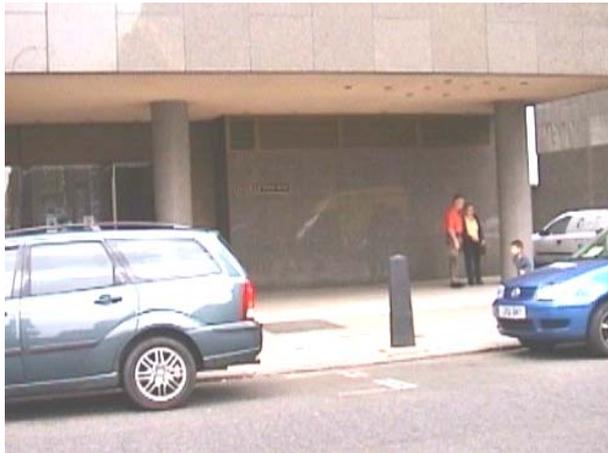
- a. Along Grafton Way, there are a number of building/office forecourts. (See Fig 25) These are very wide, deep and significantly, they all have substantial canopies, all of which make them ideal for:
  - rough sleepers
  - alternative urinals
  - clustering points for drunks/vagrants
  - arson.

Fig 25: Deeply recessed building front:

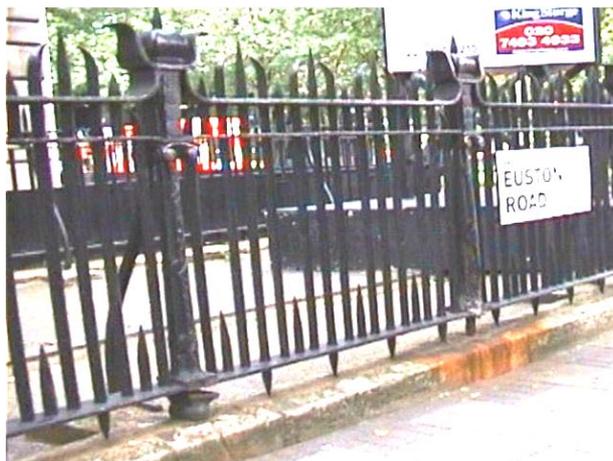
- a. This is a main office for the payment of a variety of different benefits and is regularly visited by vagrants and street drinkers.
- b. Observations suggest that a proportion of the clientele are under the influence of alcohol, and this is borne out by the beer cans etc. abandoned in the nearby basement.
- c. There is minor graffiti, damage and the area is dirty and litter strewn. The railings outside the office are in need of repair and re-decoration. (See Fig 26)
- d. Inside the main entrance the building is dirty and there is evidence of litter and graffiti much of which appears to be fairly old.

Fig 26: Poor state of repair of railings etc. (Poor environmental cues.)

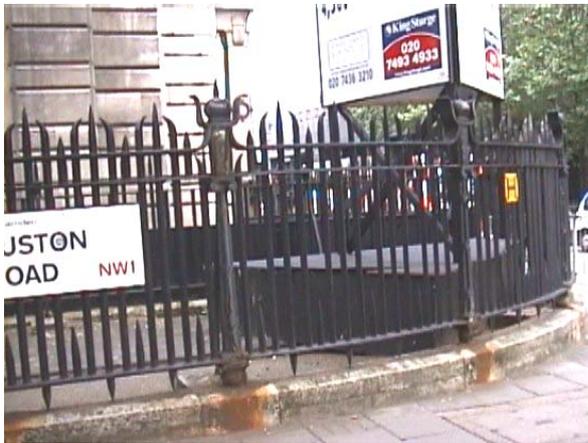
- a. This building is part of the DSS office discussed above, and appears to be largely unoccupied. The whole building is very dirty, particularly its windows, and it is giving off very poor environmental cues.
- b. The building has an exposed basement that is dirty and has litter in it.
- c. Nearby street furniture is dirty and has fly stickers.
- d. The street itself is dirty and litter strewn.
- e. Paving slabs are uneven, cracked and dirty.
- f. The pedestrian safety fence along the road side of the junction is dirty and is leaning outwards.
- g. The concrete wall into which the railings surrounding the basement have been fixed is dirty, has rust stains and has moss/algae growing on it. (See Figs 27 and 28)

Fig 27: Rust stains and general decay.

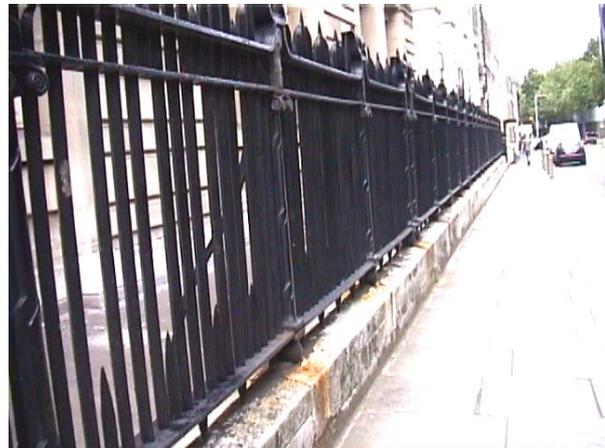
Fig 28: Continuation of view in Fig 27.

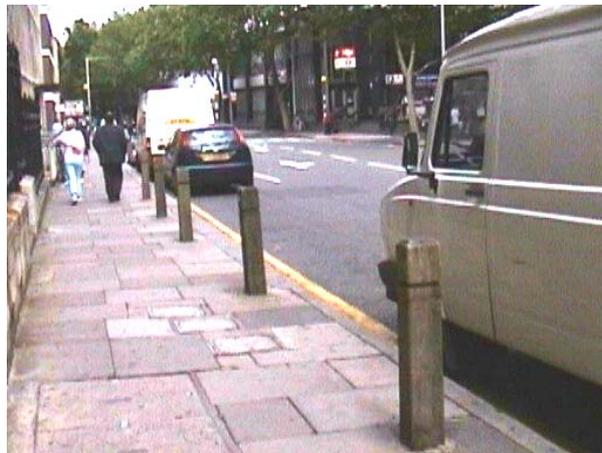
- a. Along the outside of the pavement outside Grant Thornton House, there are five wooden bollards, with a sixth broken off. It is hard to see what function these bollards are performing as they are: (See Fig 29)
  - Not strong enough to withstand a vehicle hitting them.
  - Too far apart to prevent pedestrians from crossing at this point.
- b. The broken bollard has a jagged edge that is both dangerous and aesthetically displeasing, giving rise to a 'broken windows' impression.
- c. The pavement in this area is cracked.
- d. Street furniture is dirty etc.

Fig 29: Wooden bollards.

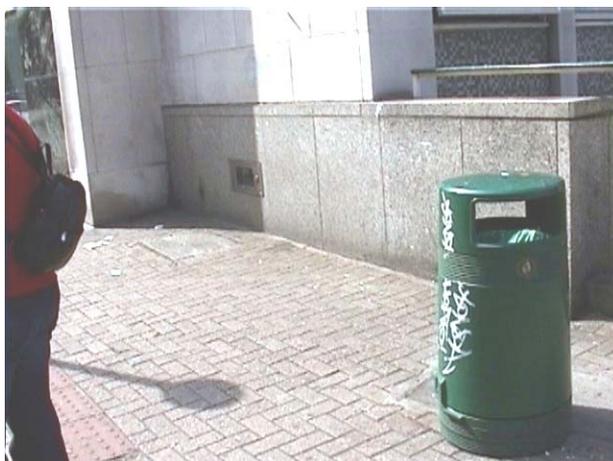
Fig 30: Graffitied litter bin and 'smokers' corner.

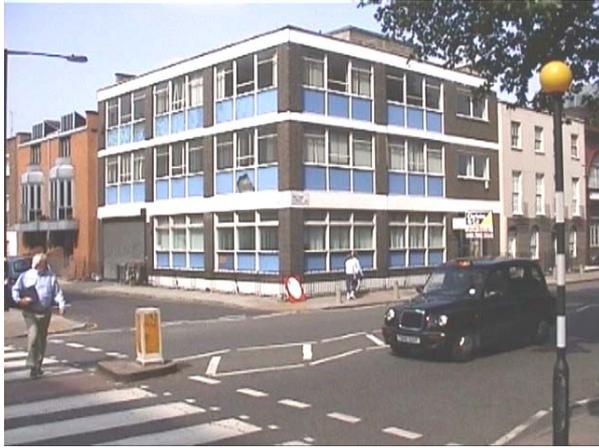
Fig 31: Unoccupied building.

- a. This building is on the opposite (north) side of the junction of Melton Street and Euston Street, and extends around the corner and up Euston Street. It is clearly unoccupied, and is showing signs of dereliction, including graffiti and peeling paintwork. (See Fig 31)

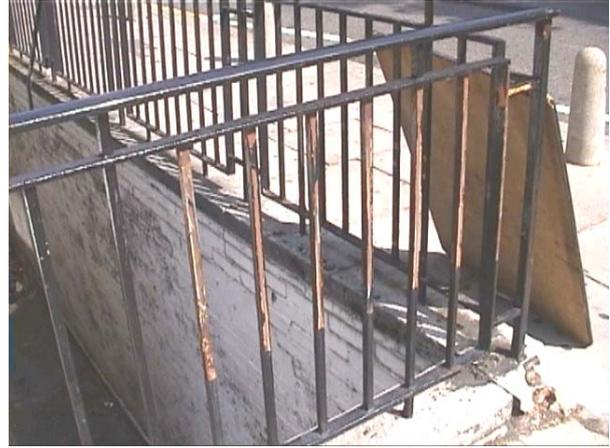
Fig 32: The poor state of the railings' repair.

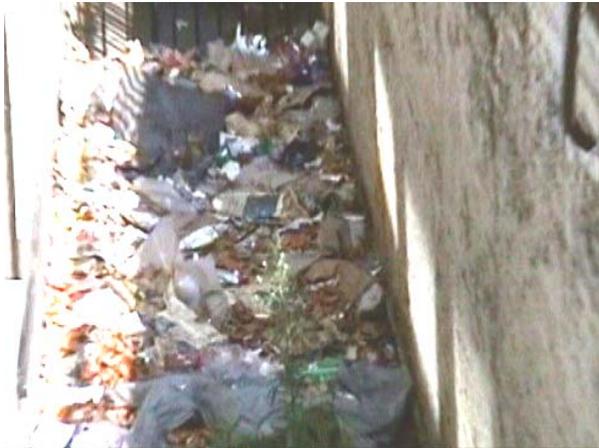
Fig 33: Accumulation of litter.

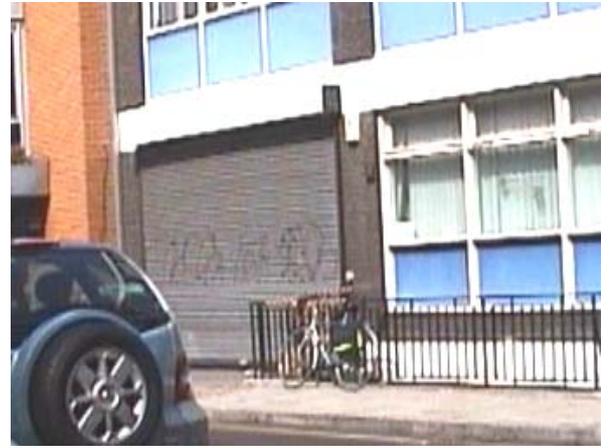
Fig 34: Permanently closed roller shutter and graffiti.

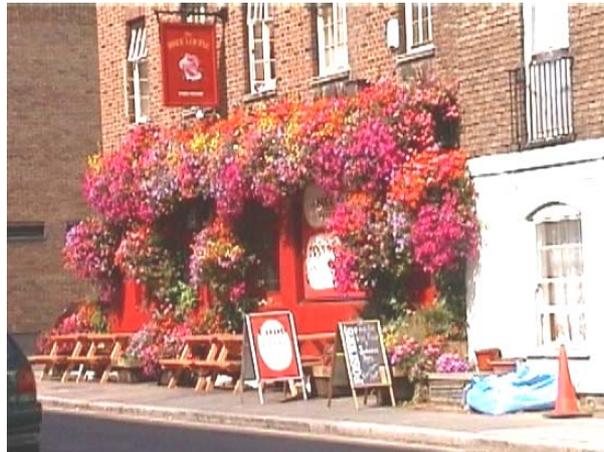
Fig 35: Contrast between bottom and top ends of Euston St.

- d. The Melton Street entrance to these premises has a short ramp that is full of accumulated litter and other filth.
- e. A closed roller shutter in Euston Street has been graffitied, and the overall appearance is in very sharp contrast to virtually the rest of Euston Street, where the houses and other buildings are in a reasonable state of repair, with hanging baskets etc. (See Figs 34 and 35)

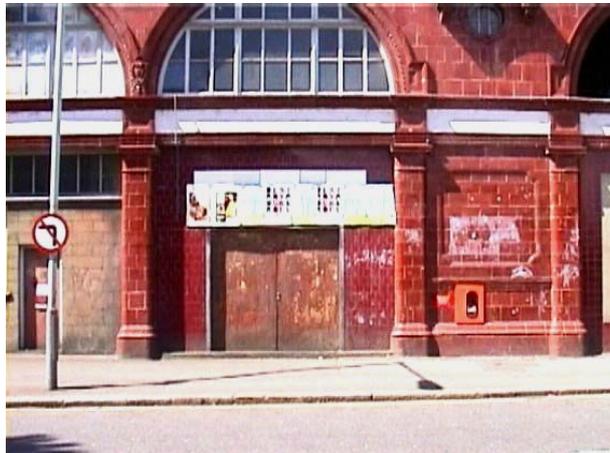
- a. This old Underground station is disused, semi derelict, and is giving off very poor environmental cues. (See Fig 36)
- b. The building is dirty, daubed with graffiti and has been extensively covered with fly posters.
- c. The steel doors are rusty, and a nearby litter bin has been daubed with graffiti.

Fig 36: Abandoned Underground Station.

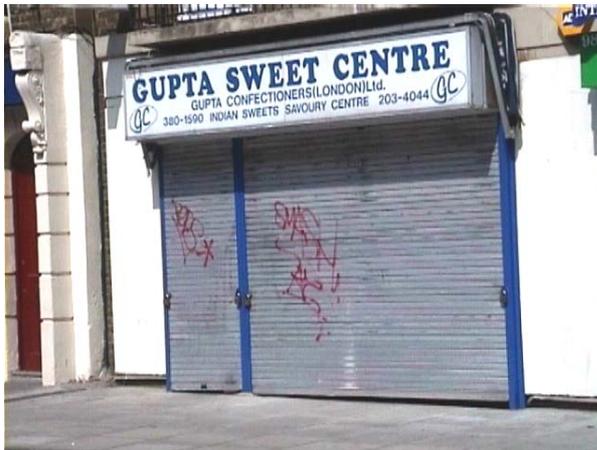
- a. Many of the walls are daubed with graffiti.
- b. Many of the shops have roller shutters that have been graffitied. (See Fig 37)
- c. A number of neon signs have been broken, and appear to have been so for some time.
- d. There are a large number of restaurants in this area, and there is evidence of people regularly urinating and vomiting in the street. (See Fig 38)
- e. There are fly posters on most of the BT junction boxes. (See Fig 39)
- f. The large Royal Mail letterbox on the junction of Drummond Street and North Gower Street has damaged paintwork<sup>xxxii</sup> and has been fly posted. (See Fig 40)
- g. Some of the street furniture has stickers; some have anti-sticker finishes some have not.

Fig 37: Graffitied roller shutter.

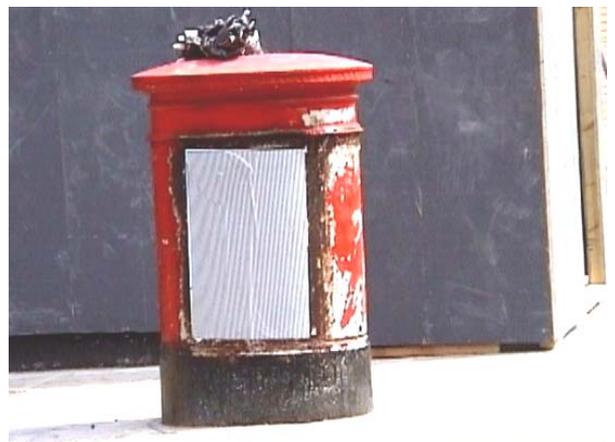
Fig 40: Badly defaced Royal Mail letterbox.

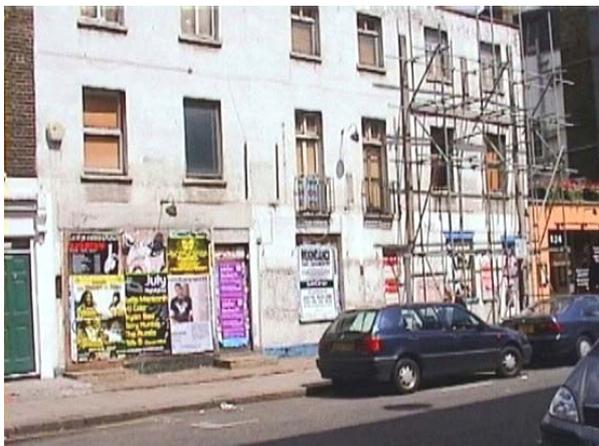
Fig 41: Apparently derelict building, showing fly posting etc.

- a. This unoccupied building is semi-derelict. It is dirty, daubed with graffiti and has illegal posters stuck to it. It appears to have been like this for some time. (See Figs 41 and 42)

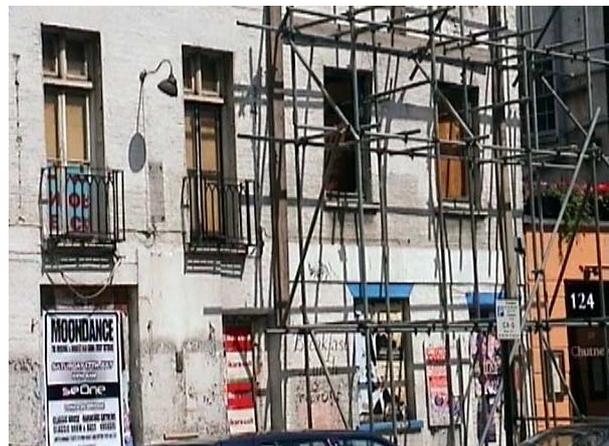
Fig 42: Close up of Fig 41.

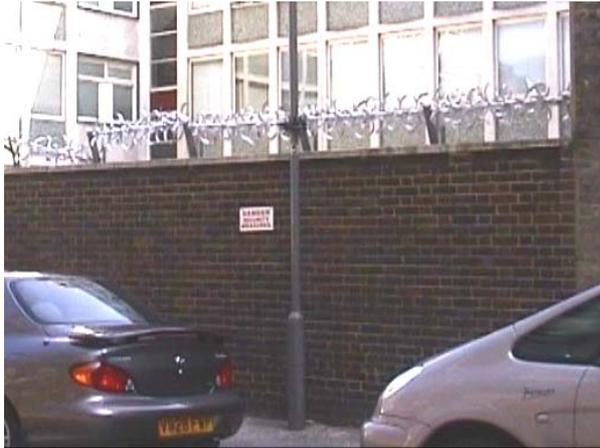
- a. Walking from Euston Street, the rear wall of 10 Melton Street (in Stephenson Way) has graffiti on it, as has the surrounding boundary wall. (See Fig 43)
- b. This wall is too low to give adequate security, and has been fitted with rotating, (broken) anti-climb cacti. (See Fig 44)
- c. Street *furniture* here is in the usual (for the project area) state of disrepair with stickers etc. In addition, anti-climb collars have been fitted to lamp posts to discourage intruders from climbing over the wall into 10 Melton Street.
- d. An old refrigerator had been abandoned on the pavement close to the wall. This would provide an excellent climbing aid over the wall of number 10 Melton Street.
- e. The way some cars had been parked would assist intruders to gain access to the wall.

Fig 43: Rear wall of 10 Melton Street showing graffiti.

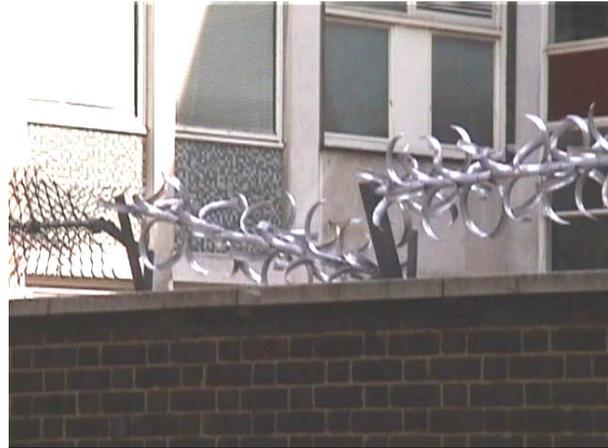
Fig 44: (Broken) anti-climb cacti.

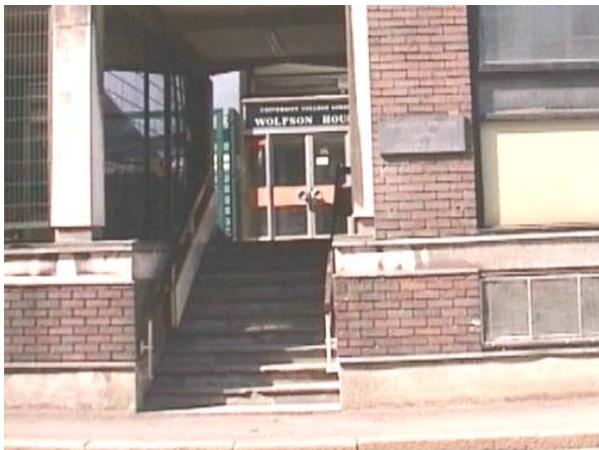
- a. This building that is part of UCL is in a poor state of repair, is dirty, has graffiti on its walls, and gives off a powerful feeling of menace.
- b. There is a raised patio with tables and chairs at the front of the building that seems to be some form of terrace for a student bar. It was noted that both the area and the tables in the area were dirty, strewn with litter and as far as could be seen, appeared to be a very unpleasant area. (See Figs 45–47)

Fig 45: Entrance to Wolfson House.

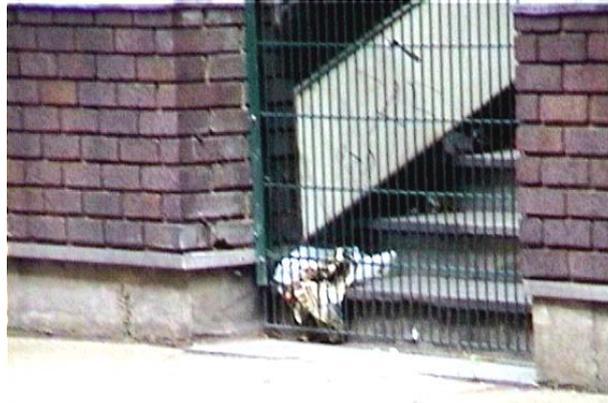
Fig 47: Close up of arrow (Fig. 46), showing closed off rear of Wolfson House.

- c. These observations were made in bright sunlight, and although the lights were on in the patio, the area was still relatively dark, and the lighting was poor with alternating pools of light and dark.
- d. The building has steps up to the patio level and this area has an access control device on a door leading into the University building. This whole area is enclosed with broad gauge wire mesh and gates at the top of the steps, but this configuration would allow vagrants and rough sleepers to sleep on the steps.
- e. It is therefore highly probable that this area will be vulnerable to a number of offences including:
  - rough sleepers
  - arson
  - robbery
  - drunkenness
  - drug offences
  - criminal damage
  - general anti-social behaviour.

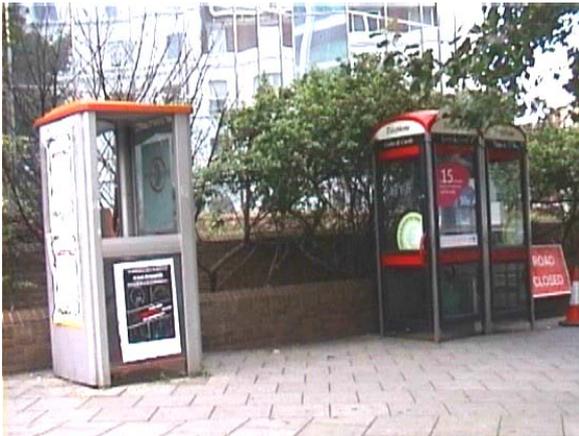
- All three are dirty and show obvious signs of being used as alternative lavatories.
  - All have advertising cards for sexual services illegally on display.
  - All have illegally pasted posters on display.
  - Information suggests that they are also used for drug dealing.
  - All three boxes display legal advertisements that are obscuring vision of the inside of the boxes.
  - All three boxes appear to be out of the range of the street lighting.
- c. There are two distinct brick planters on this junction close to the corner of the building at 250 Euston Road. The smaller, lower of the two is full of rubbish, its trees and foliage are in very poor condition, and information suggests that it is used for hiding drugs. (Fig 49)

Fig 48: Damaged and misused telephone boxes.

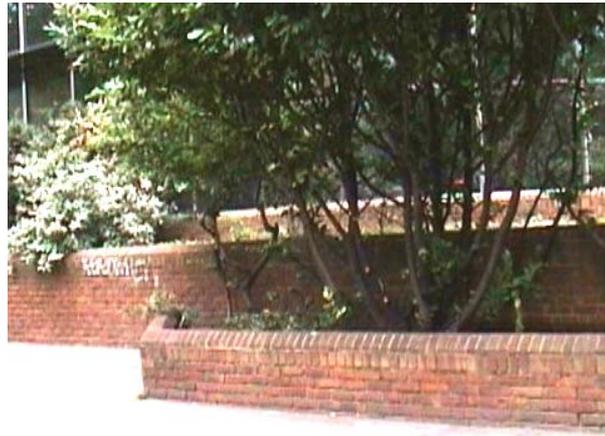
Fig 49: Vandalised etc. brick planter. Note graffiti on nearby walls.

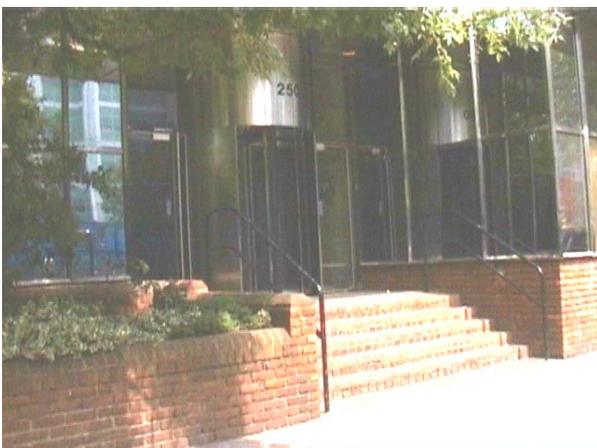
Fig 50: Entrance to 250 Euston Road.

- d. The larger of the planters is in a similar state to the smaller one.
- e. Nearby is the main entrance to 250 Euston Road. It is up some steps and obscured by bushes. This is an enormous building with hundreds of mirror finish, very dirty, windows. (See Figs 50 and 51)
- f. Nearby bus shelters have been daubed in graffiti, as has the pre-boarding ticket machine.
- g. It is therefore highly probable that this area will be vulnerable to a number of offences including:
- rough sleepers
  - robbery
  - drunkenness
  - drug offences
  - criminal damage
  - general anti-social behaviour
  - prostitution.

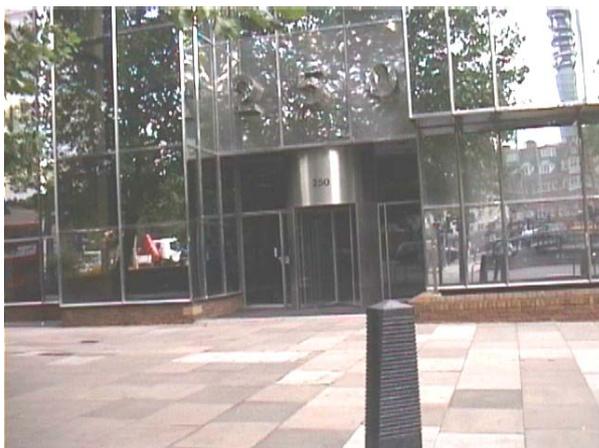
Fig 52: Continuation of 250 Euston Road.

- a. This area, which is a continuation of Euston Road and of number 250 is equally as filthy, graffiti daubed and inundated with rotting litter as under the last heading. (See Fig 52)

- i. The solutions for this area are the same as those set out in 7.13 plus the following additions.
- ii. The disused entrance to the Underground should be removed and levelled to remove the convenient angles for both litter and drug dealers.
- iii. The basement at 250 Euston Road should be cleaned out, and the safety railings around the public side be raised by about two metres. They should also be filled in with aesthetically pleasing mesh to reduce the probability of rubbish being dumped.
- iv. Consider enforcement action by appropriate agencies.
- v. Consider if Section 17 Crime and Disorder Act 1998 will assist in any of these actions.

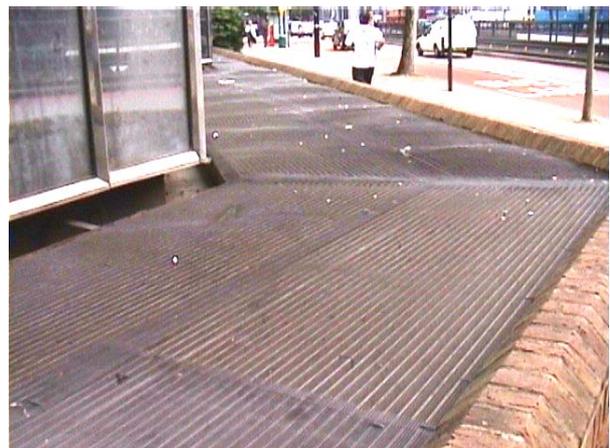
Fig 53: Mesh 'lid' with litter deposited on it.

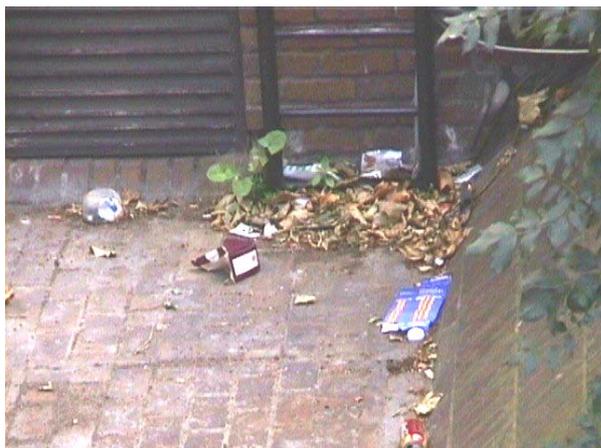
Fig 54: Litter in basement area of 250 Euston Road.

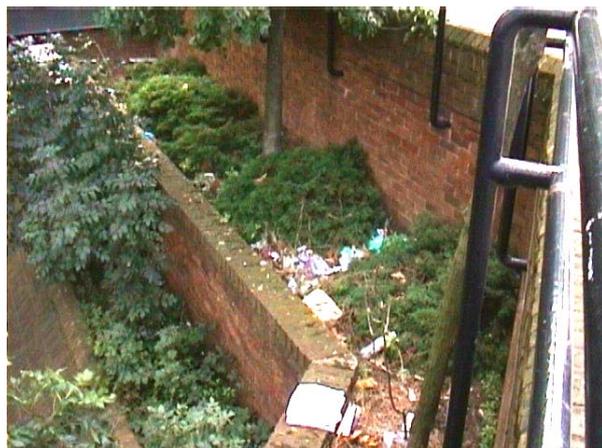
Fig 55: Litter in basement area of 250 Euston Road.

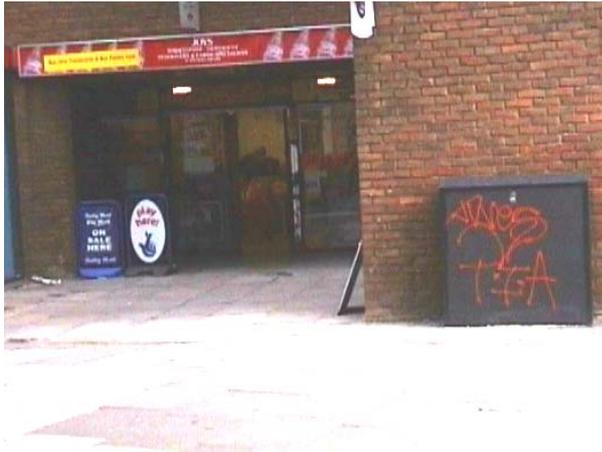
Fig 58: Entrance to Joy's shop showing graffiti.

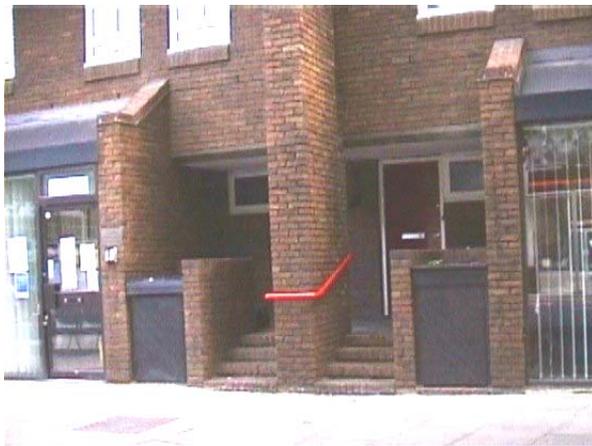
Fig 60: Inset fronts of flats in Hampstead Road.

- c. Because the fronts of the flats open directly onto the public footpath in an area of such high anonymity in a 'broken windows' area, the space is not defensible.
- d. The frontage of the Camden People's Theatre is dirty; graffiti daubed and presents a somewhat unpleasant, threatening image. This will avoidably, be raising the fear of crime and contributing to the 'broken windows' situation.

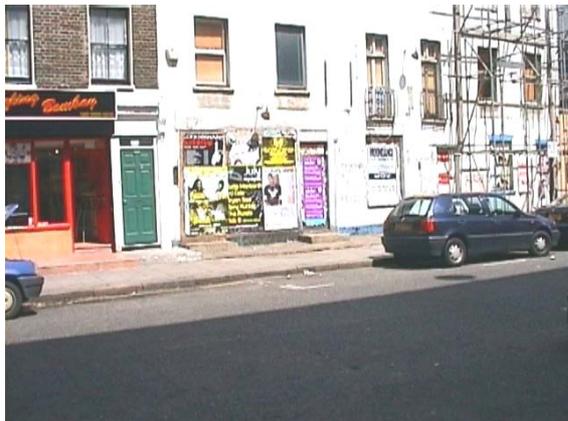
Fig 62: The area of Drummond Street close to the Tolmer's Square entrance.

- b. The rear of the large office complex, whose frontage is at the junction of Euston Road and Melton Street (250 Euston Road), forms a part of the interior landscape of this square.
- c. The Square is close to the derelict building in Drummond Street discussed earlier and is undoubtedly being influenced by the problems identified there. In turn, this area is itself exercising an undue situational influence over the general area. (See Fig 62)
- d. The entrance into the square off Drummond Street has a metal vehicle barrier, but even when closed, this would not stop pedestrians entering the square. It would in fact create what amounts to a 'leaking cul de sac', recognised as a particularly crime-prone design set. (See Figs 63 and 64)

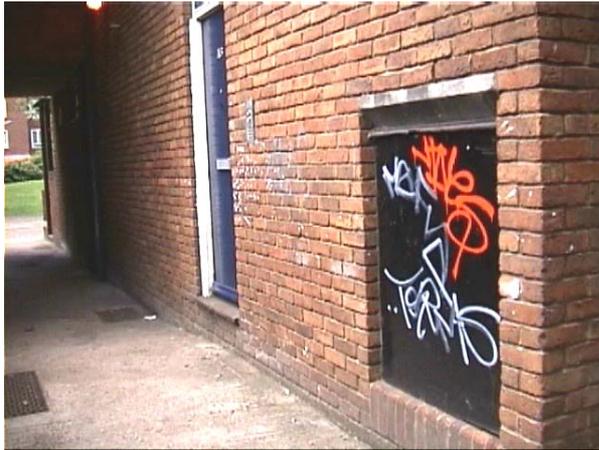
Fig 65: Entrance to a dwelling situated along the movement generator entrance into the Square, with graffiti litter etc.

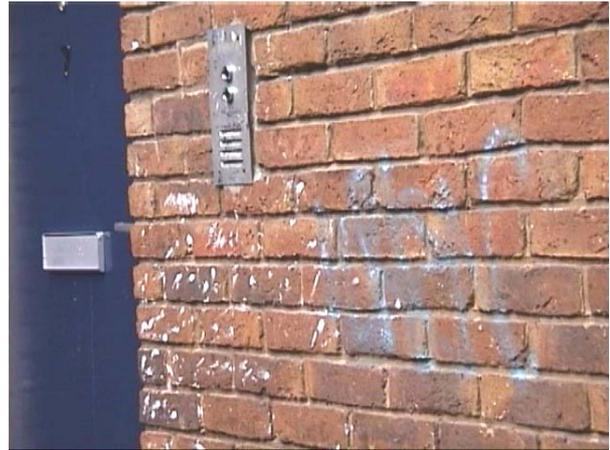
Fig 66: Close up of Fig. 65.

- e. Other entrances and exits into the Square are equally badly designed and are not only creating complete permeability, through the Square in most directions, but are also creating the impression of entering a hostile environment. (See Figs 65–67)

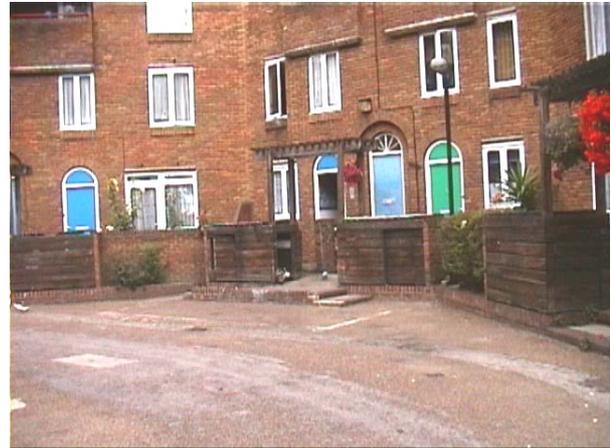
Fig 68: A dwelling entrance close to the Joy's shop entrance into The Square. Note the inset nature and the ease with which offenders could hide.

- f. The external condition of the domestic residences in the square varies and shows signs, not only of neglect, but also of clear criminal damage. Some front doors are clean with intact paintwork, whilst others (believed to be mainly common doors to upstairs maisonettes) are defaced with graffiti, have peeling paintwork, are damaged in some way and are badly in need of renovation. (See Fig 68)

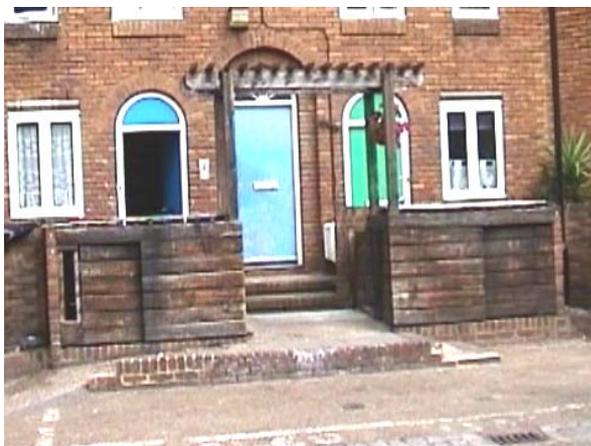
Fig 69: Close up showing damaged woodwork.

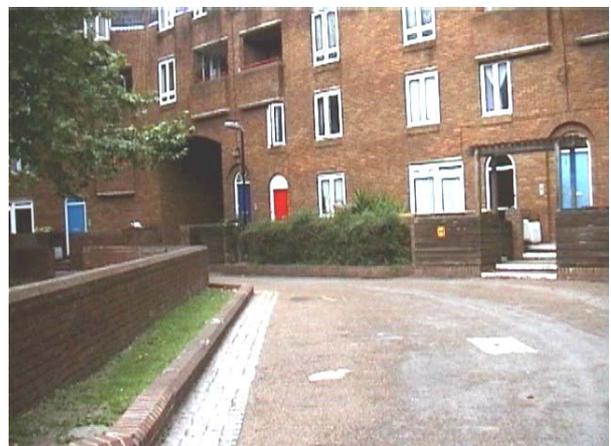
Fig 70: Fronts of dwellings showing proximity of the walled garden (on the left).

- h. The fronts of the majority of the dwellings are very close to the walled garden, reducing the levels of territoriality which residents are able to exert over their environment. (See Fig 70)

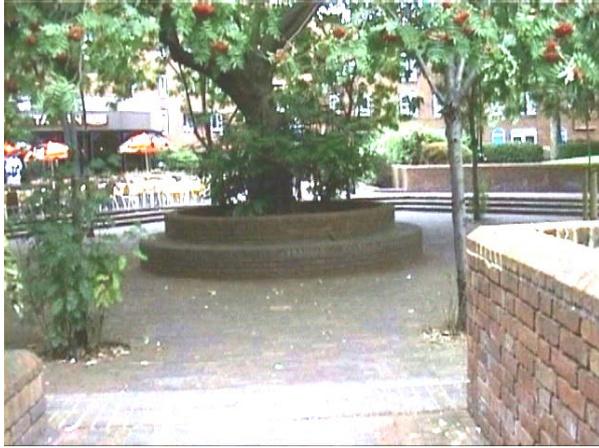
- i. What lighting there is in the square is inadequate in terms of crime prevention.
- j. In the centre of the square is a garden area with trees and bushes, many of which are overgrown. All the foliage in the area appears to be neglected,<sup>xxxv</sup> as does the brickwork surrounding the garden. (See Figs 71 and 72)

Fig 71: The walled garden from one of the entrances.

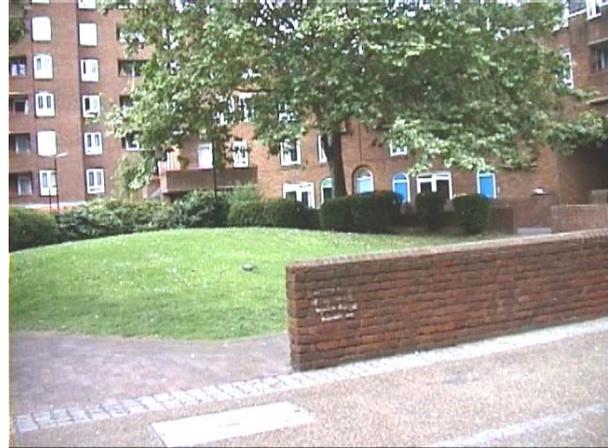
Fig 72: Walled garden from a different angle.

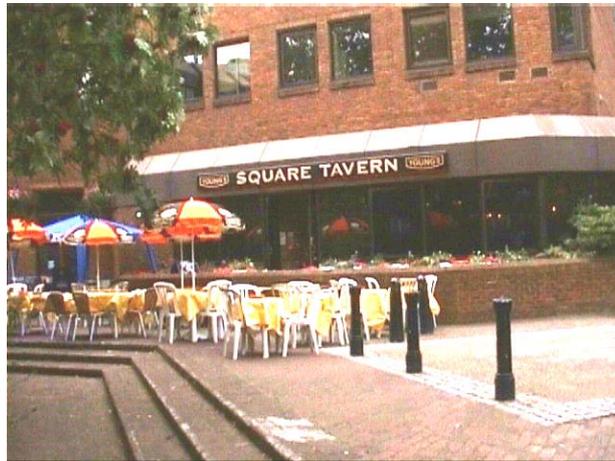
Fig 73: The pub and its outdoor tables and chairs.

- k. The garden area has significant amounts of litter in it.
- l. The pub has a large amount of outdoor tables and chairs between itself and the garden, and clearly when the pub is trading, the noise would be disturbing to the residents in the surrounding dwellings. (See Fig 73)
- m. The newsagent's frontage is heavily graffitied, with lockable shutters that are never opened, as are the shutters of a number of other premises around the square. It was noted that debris from the old people's flats above the newsagent's was lying on the roof of the shop. Allegedly, this has been there for some time. The exterior of the newsagent is in urgent need of renovation. (See Figs 74–76)

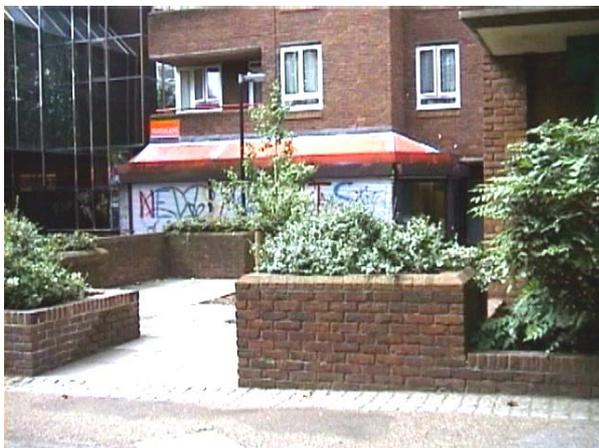
Fig 74: The newsagent's roller shutters with graffiti.
