## **Annex 11 – Case study: London Borough of Camden**

Building Research Establishment Ltd, UK

August 2004

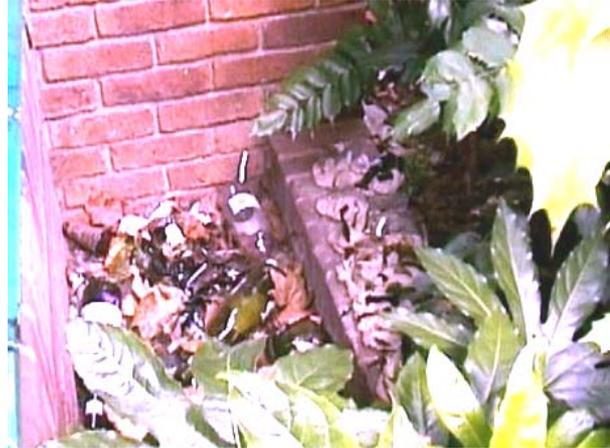
- n. The whole area is neglected and is very dirty with litter, graffiti and broken glass in large quantities all over. In some cases, the broken glass has been deposited deliberately, allegedly to deter drug addicts and dealers. (See Figs 77–79)

Fig 77: Accumulation of broken glass.

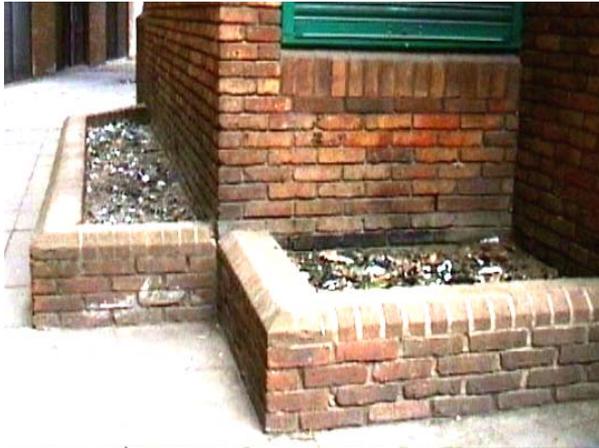
Fig 78: Broken glass has been deliberately put out, allegedly to prevent drug addicts from using this planter as an alternative lavatory.

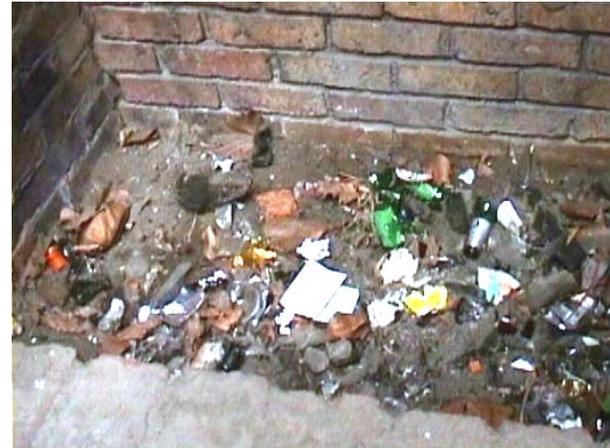
Fig 79: Close up of Fig. 78.

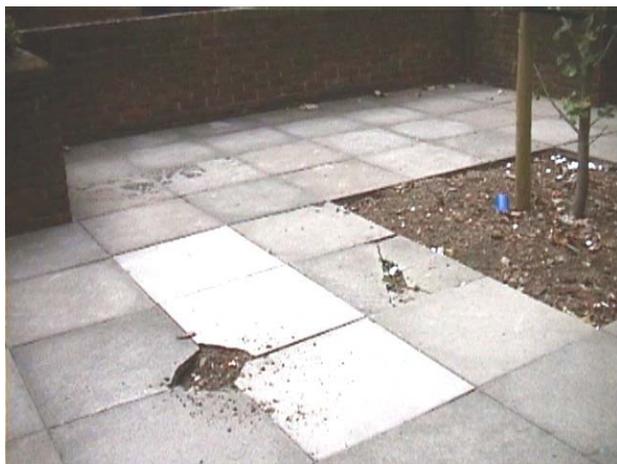
- o. Throughout the Square, many of the paving slabs are uneven and cracked. (See Fig 80)
- p. The mirror finish windows at the rear of 250 Euston Road are all very dirty giving the whole area an appearance of neglect and semi dereliction. (See Fig 81)
- q. There is evidence of arson in a number of places, allegedly caused by drug addicts.
- r. There are a number of brick built planters with evidence of having been used as alternative lavatories, barbeques etc.
- s. This is a major problem area with potential for very serious crime and disorder including:
- burglary
  - arson
  - robbery
  - criminal damage
  - drunkenness
  - drug dealing
  - drug abuse
  - prostitution
  - general anti-social behaviour.

Fig 80: Broken paving slabs.

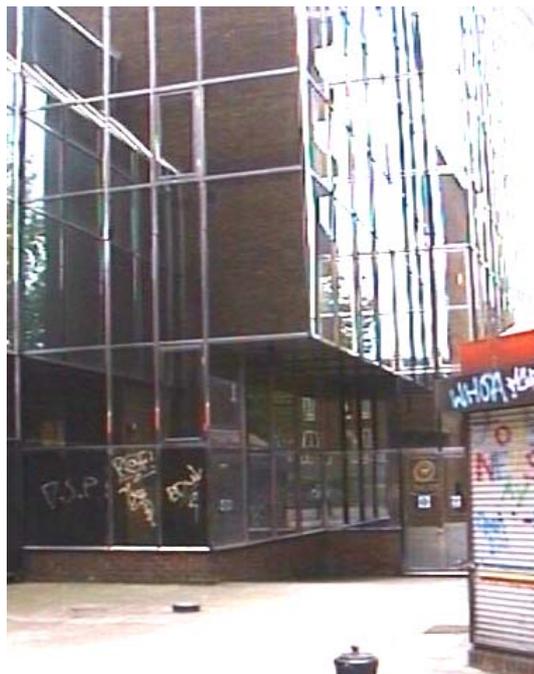
Fig 81: Mirror finish windows plus graffiti
